# Team Update 18

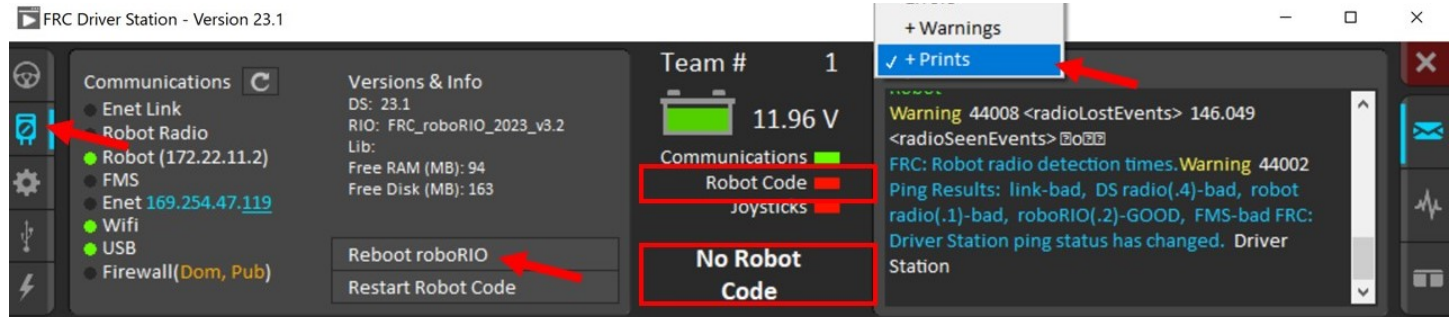
We are tracking an issue being reported where previously working Robot Code does not load as expected on roboRIO boot, as shown by the “No Robot Code” indication in the image below persisting for longer than usual, and no messages related to robot code starting to appear in the console, shown by pressing the Gear icon then the +Prints button shown below. In these cases, the code generally does load properly after the roboRIO is rebooted using either the Reset button or the “Reboot roboRIO” button in the Diagnostics tab of the Driver Station software. We are still in the process of trying to reproduce this issue and identify the root-cause. FIRST Technical Advisors (FTAs) and Control System Advisors (CSAs) were advised to be aware of this issue and work with teams to reboot their roboRIO prior to a match if encountering this issue.
